# Debris/Ice/TPS Assessment And Photographic Analysis For Shuttle Mission STS-38

Gregory N. Katnik  
NASA/Kennedy Space Center

February 1991

November 15, 1990

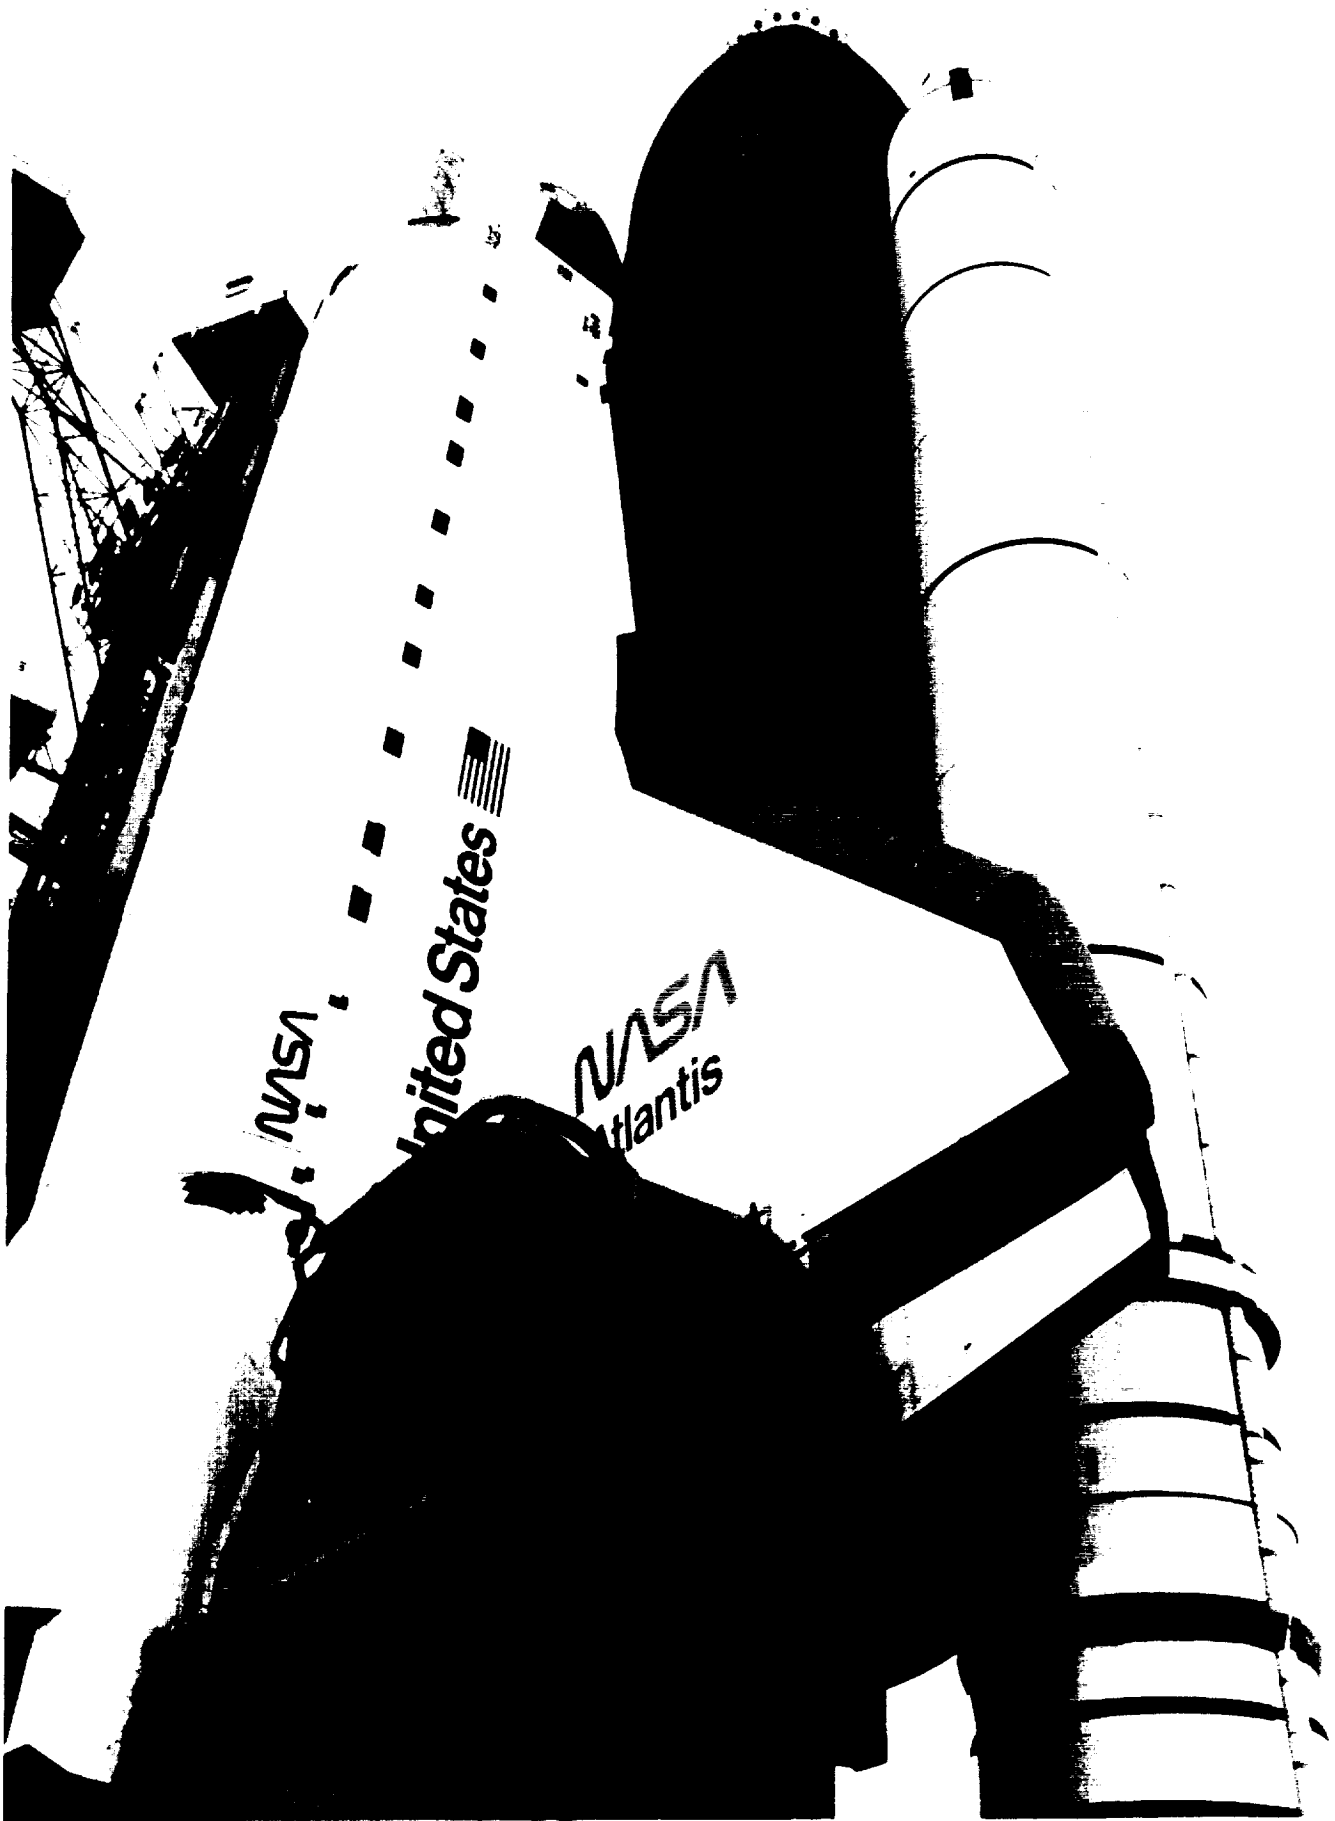
Overall view of OV-104, ET-40, and RH SRB BIO39. No ice/frost had formed on the External Tank TPS acreage.

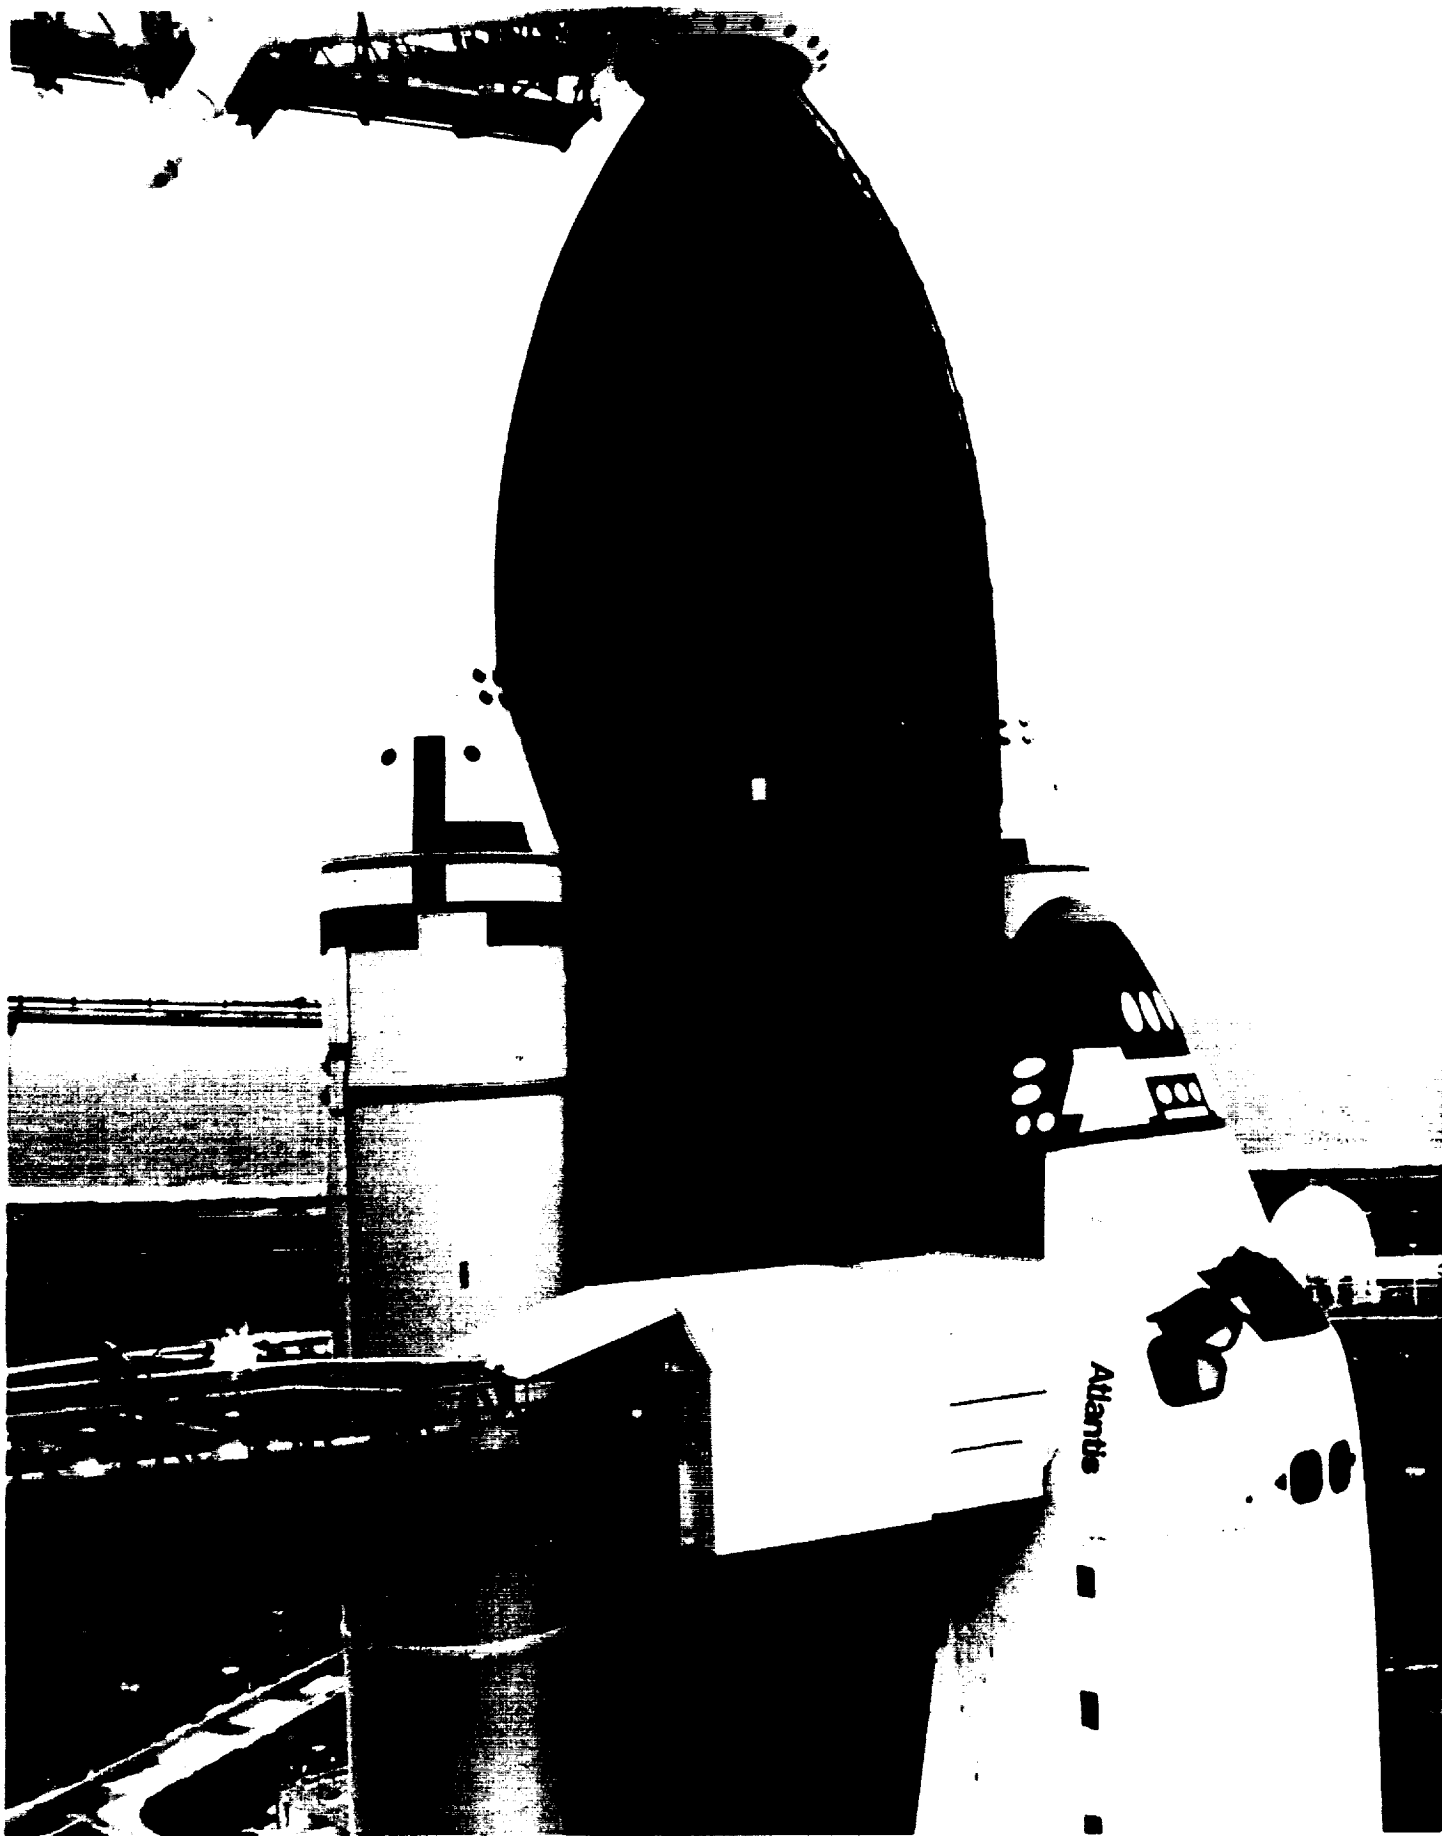
Overall view of ET-40 L02 tank and upper LH2 tank -Y+Z side. No ice/frost had formed on the ET TPS acreage.

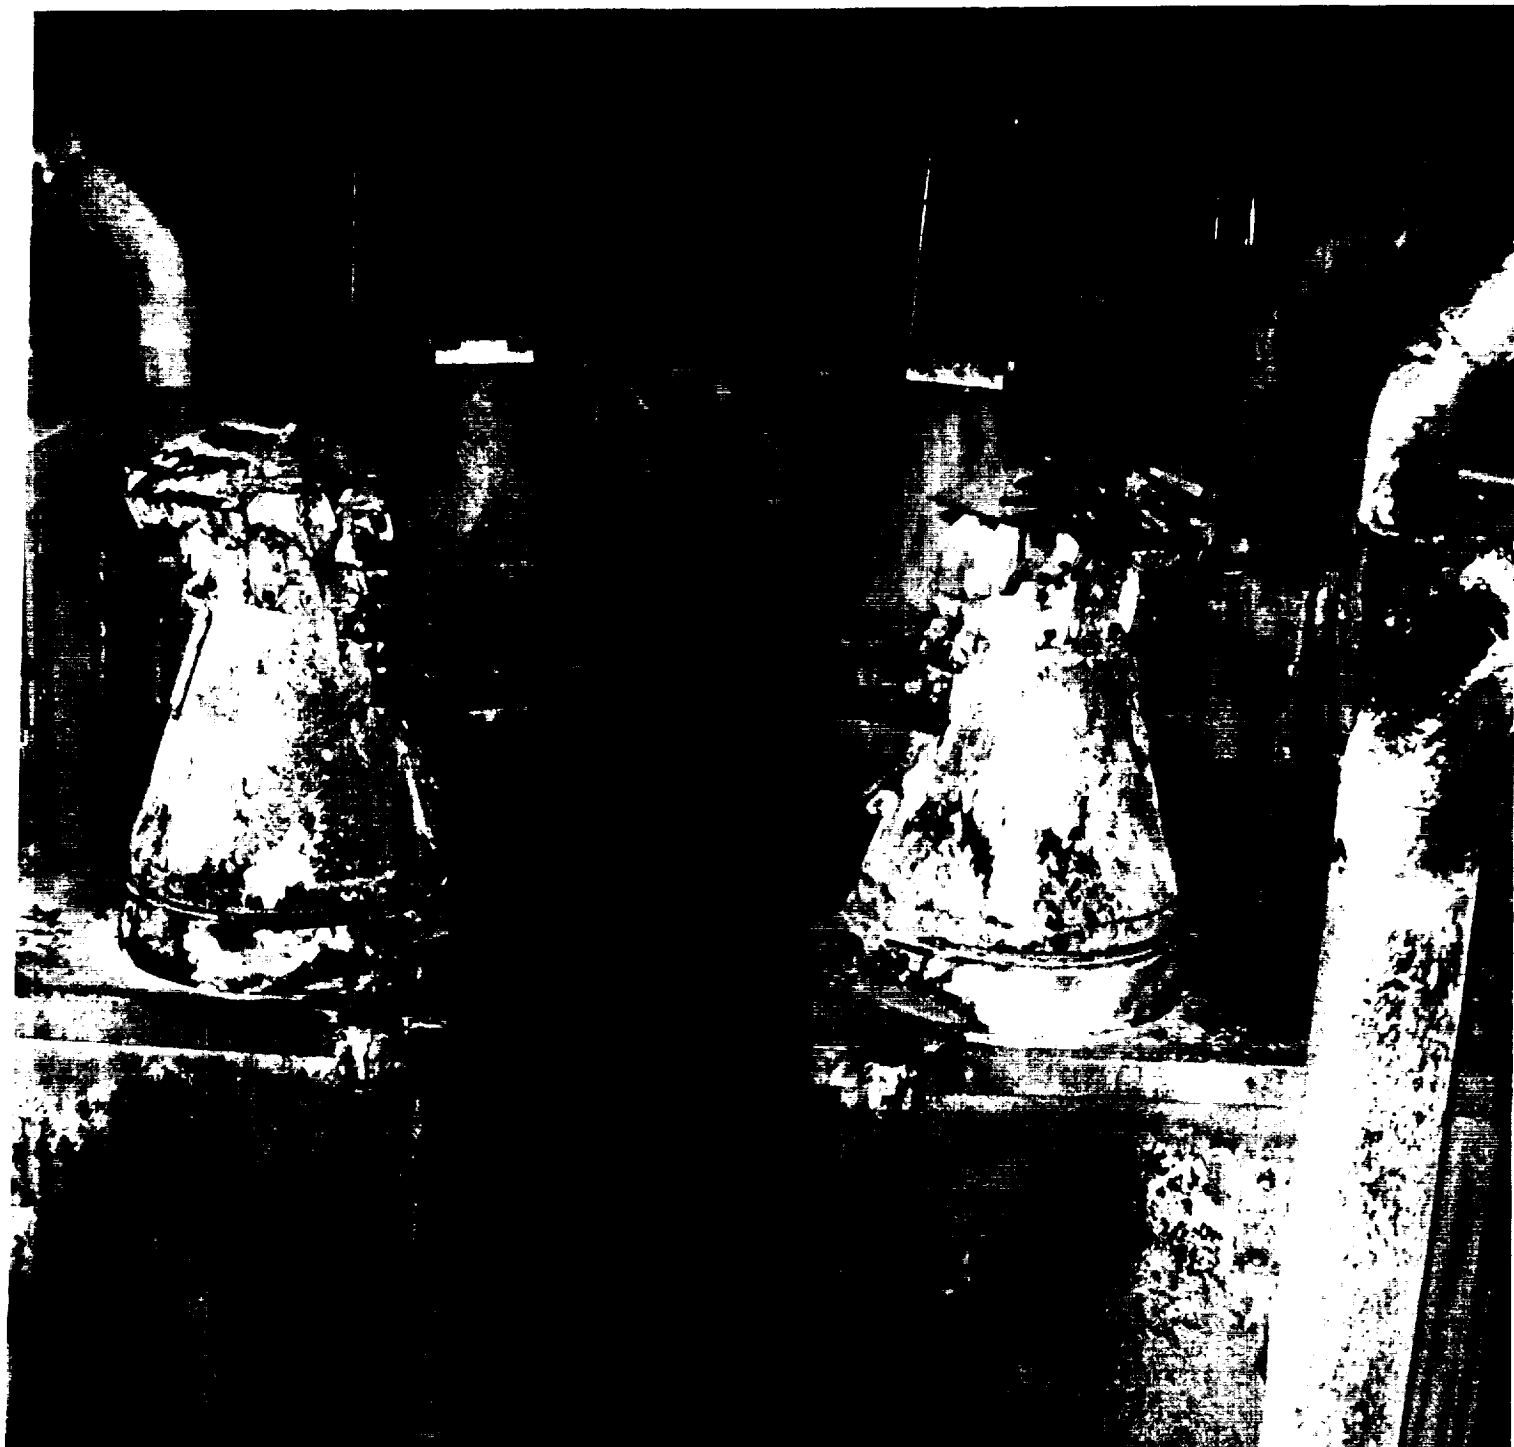
Post launch condition of RH SRB holddown posts. Note SRB plume effects on north posts compared to little effect on south posts

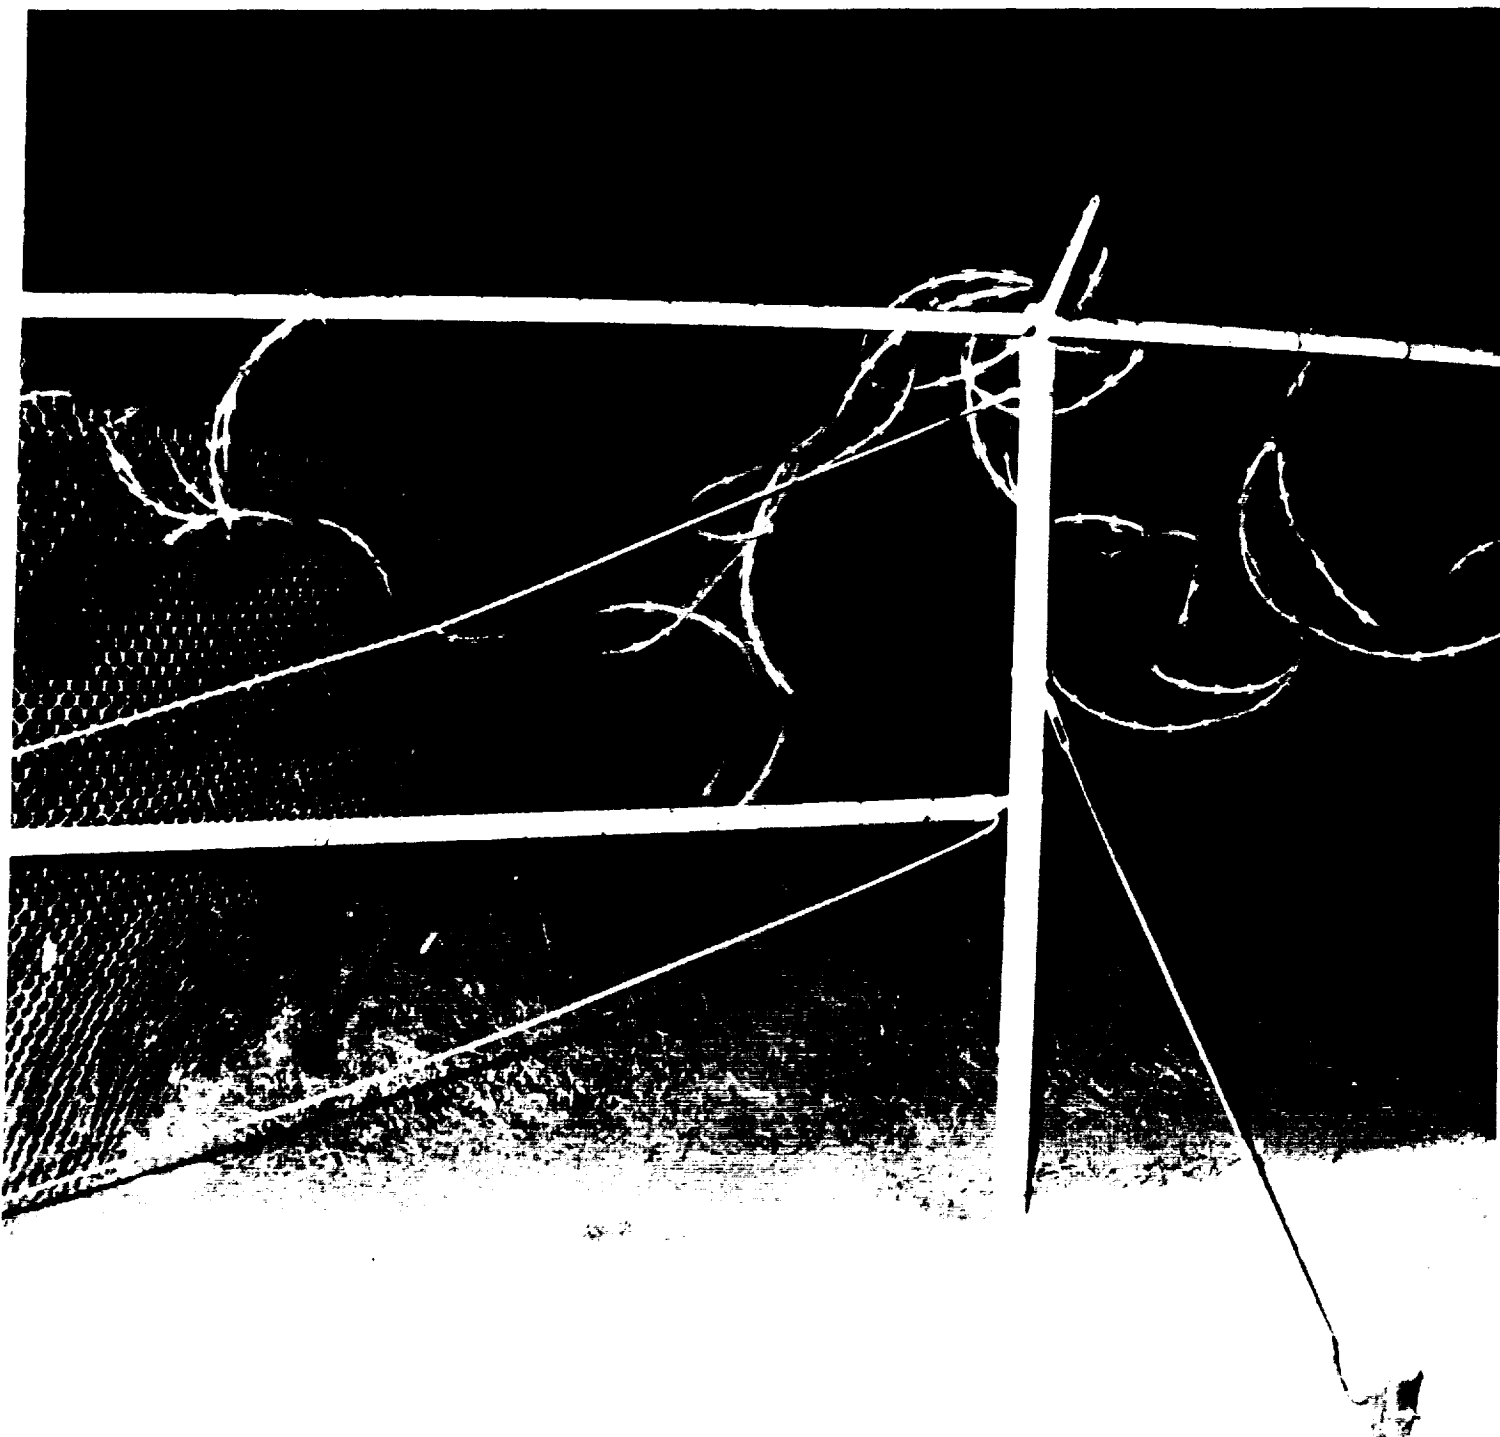
SRB exhaust plume from the pad flame trench caused damage to  
the north pad perimeter fence

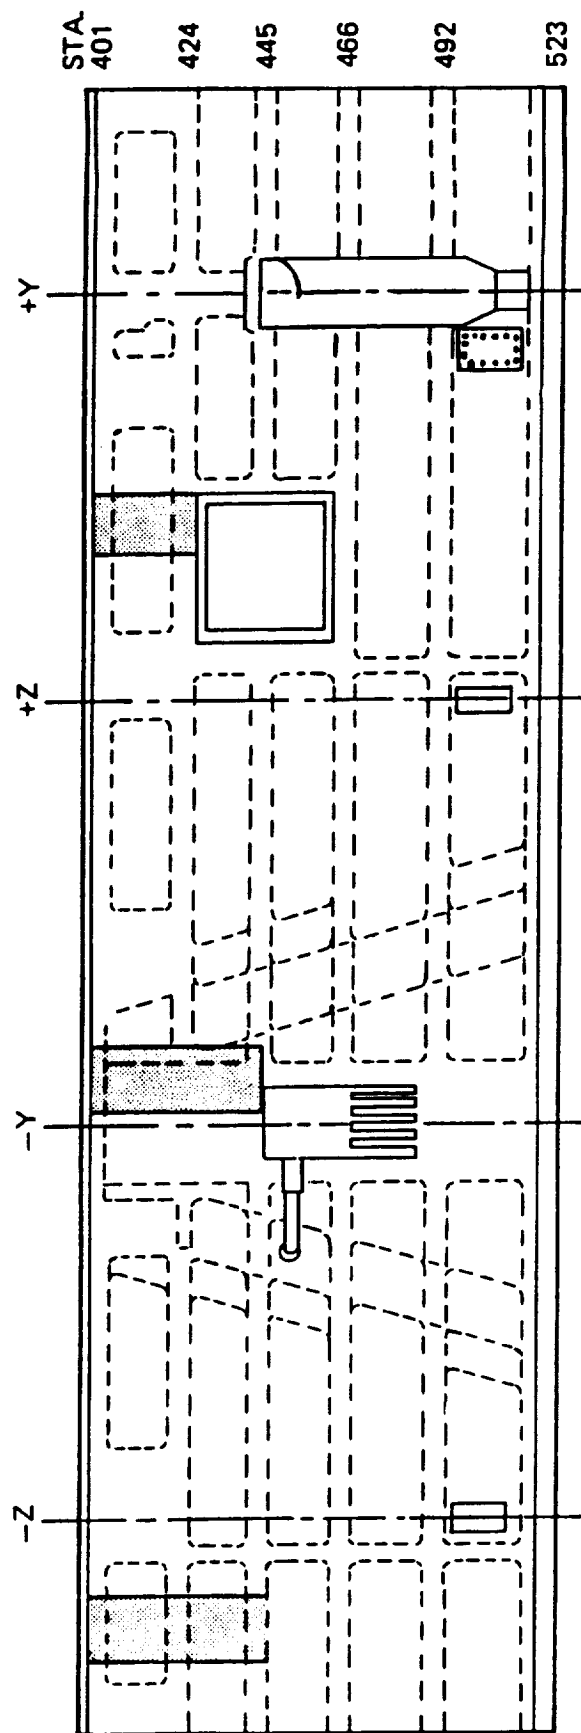
FIGURE 6. RIGHT SRB FWD SKIRT

DEBONDS  
NONE

TPS MISSING  
NONE

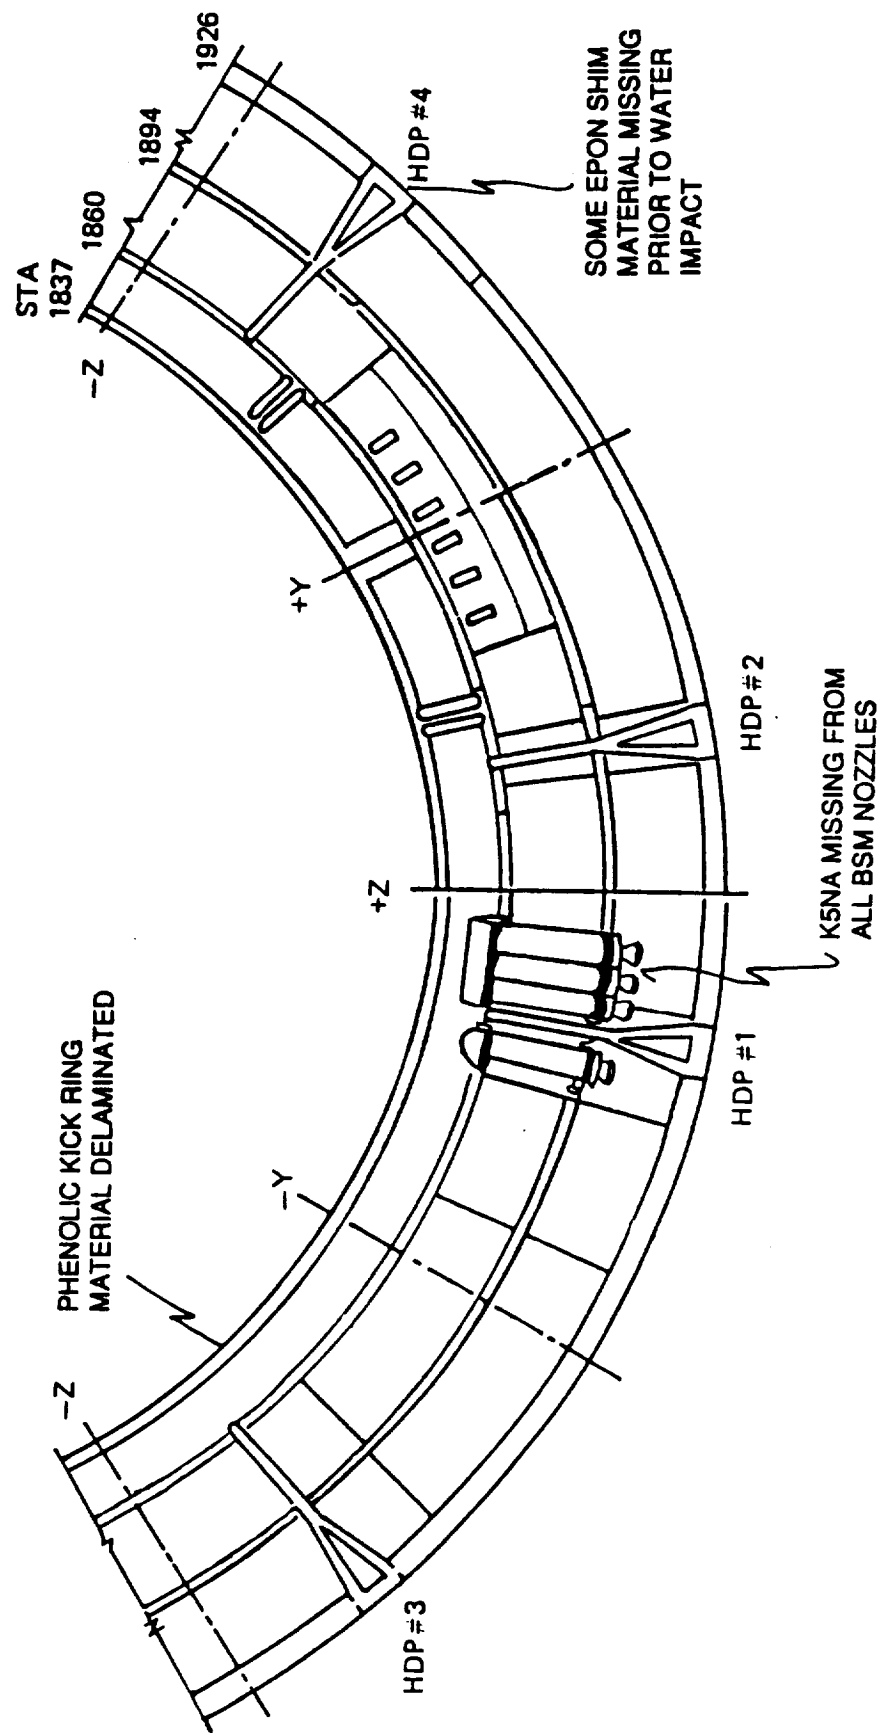
FIGURE 7. RIGHT SRB AFT SKIRT EXTERIOR TPS

The TPS over the aft skirt acreage was generally in good condition with localized blistering of the Hypalon paint (Figure 7). The TVC system appeared to be undamaged. The phenolic material on the kick ring delaminated in several locations. K5NA protective domes were missing prior to water impact at 5 locations. K5NA was missing from all aft BSM nozzles. Instafoam was missing from the aft ring around the aft skirt feet, HPU exhaust horns, and the SRB T-0 umbilical. All four Debris Containment System (DCS) plungers were properly seated. Some Epon shim material was missing from the aft skirt HDP #4 foot and the substrate was sooted. This condition coincides with the piece of EPON shim material that came loose after liftoff (ref Film Item E-7).

ALL DCS PLUNGERS  
WERE PROPERLY SEATED

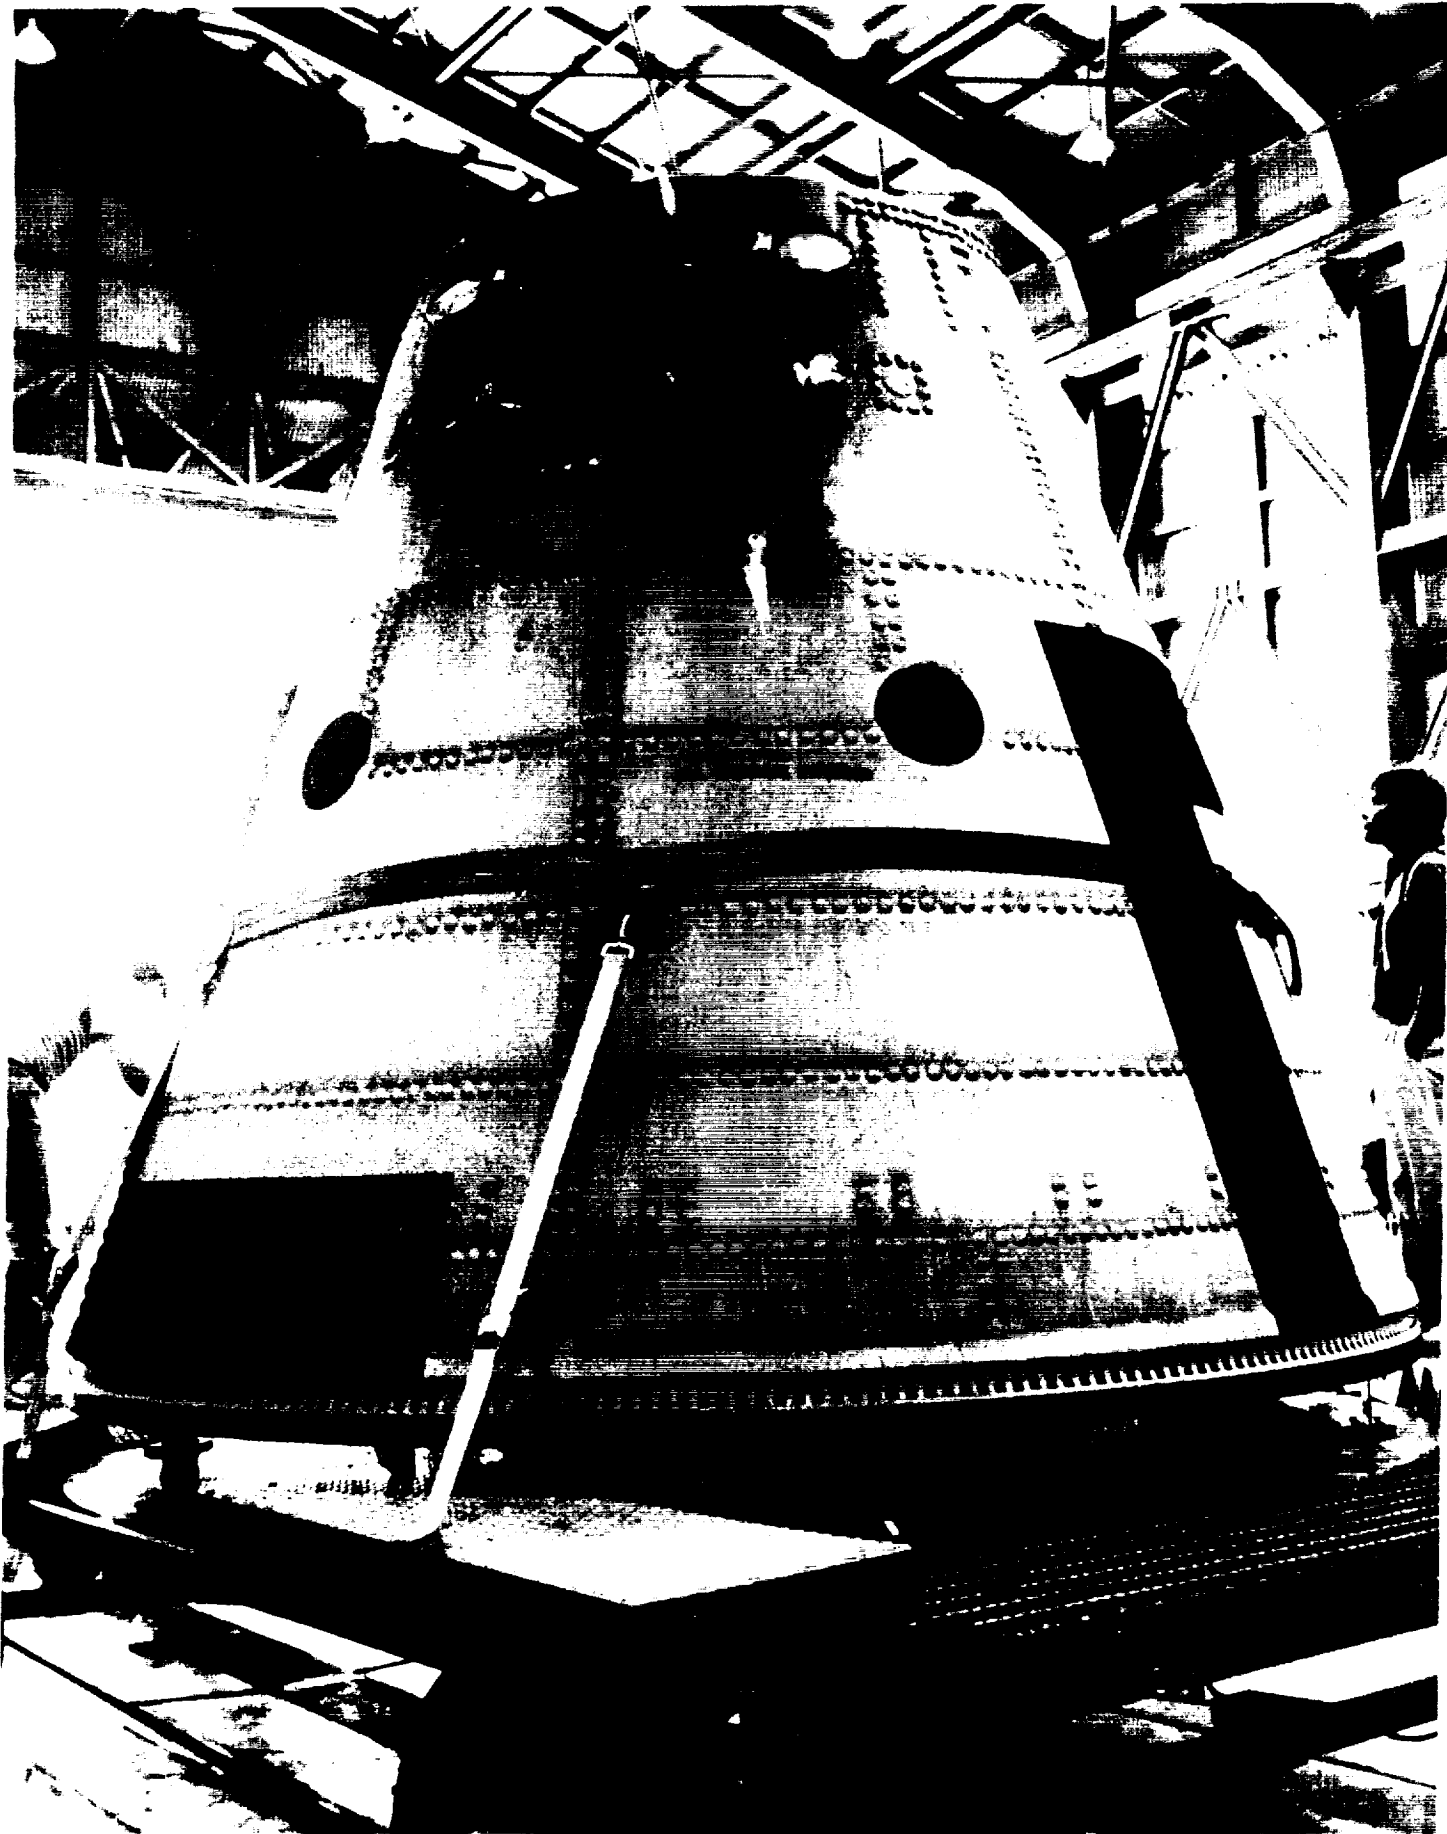
Post flight condition of the RH SRB frustum. There were 56  
MSA-2 debonds over fasteners, but no areas of missing TPS

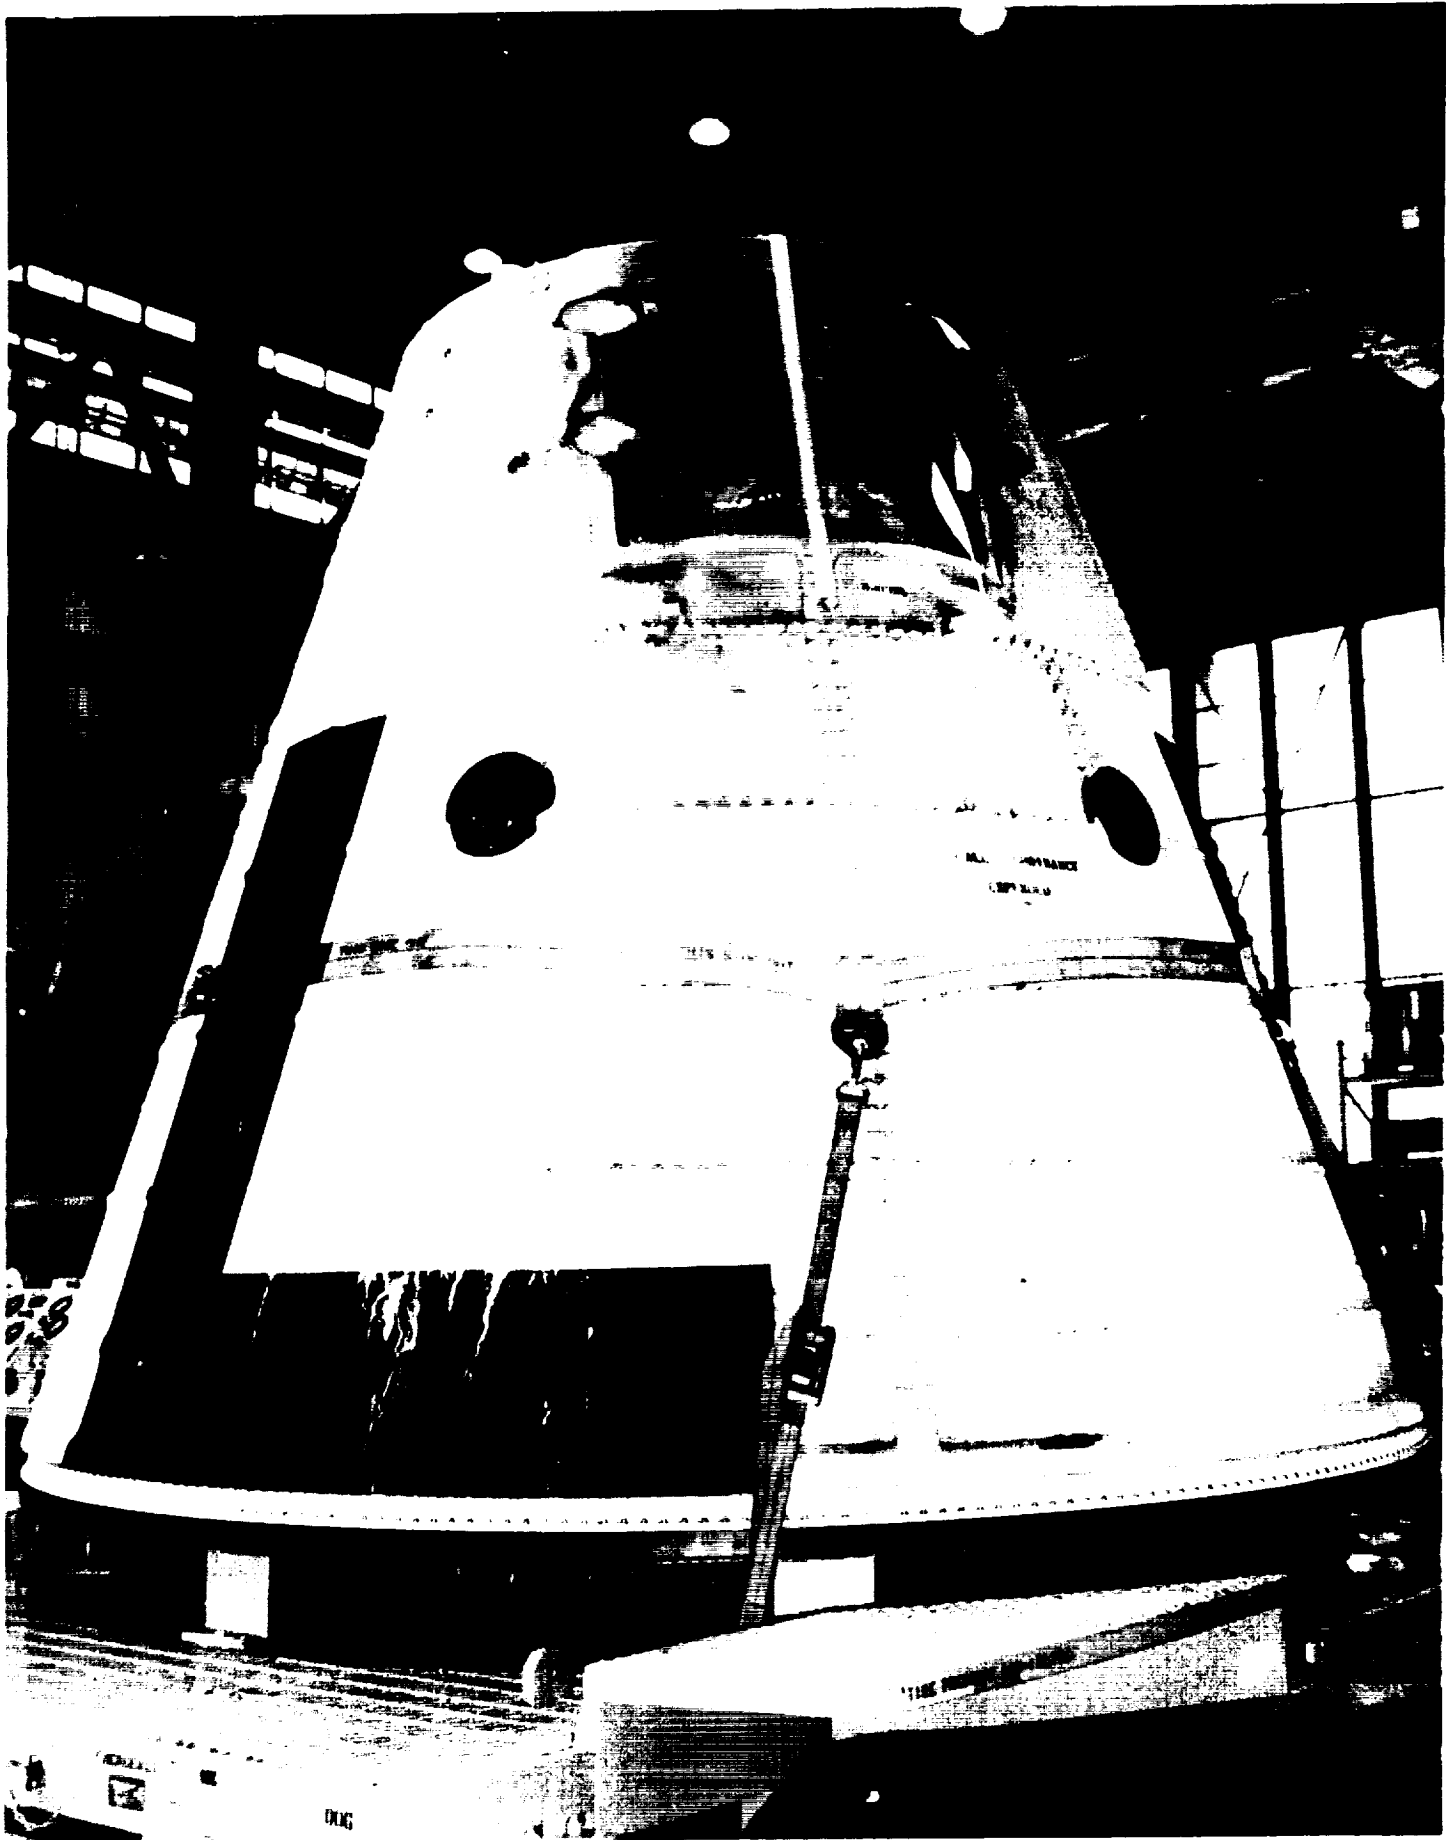
Post flight condition of LH SRB frustum. There were 54 MSA-2 debonds over fasteners, but no areas of missing TPS.

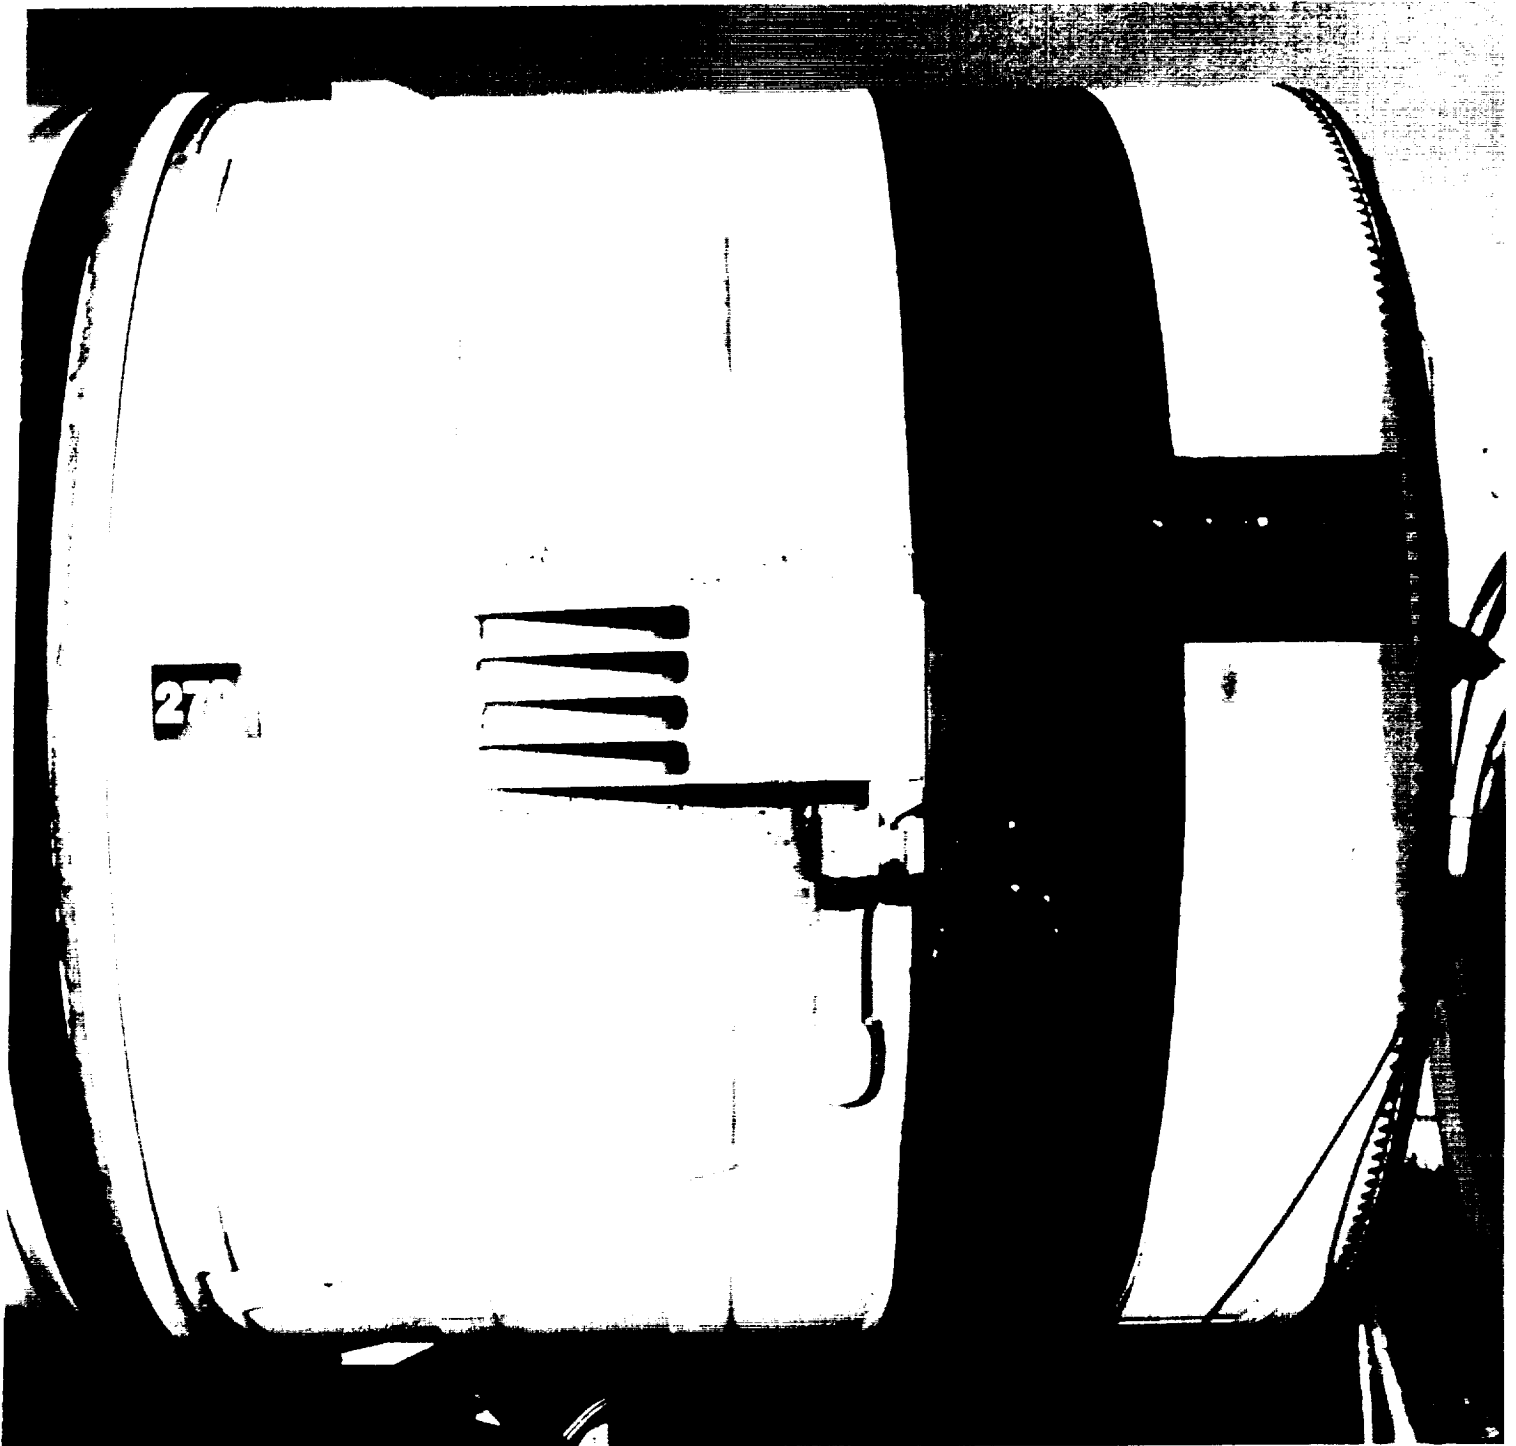
Post flight condition of LH forward skirt. There were no  
MSA-2 debonds or areas of missing TPS.

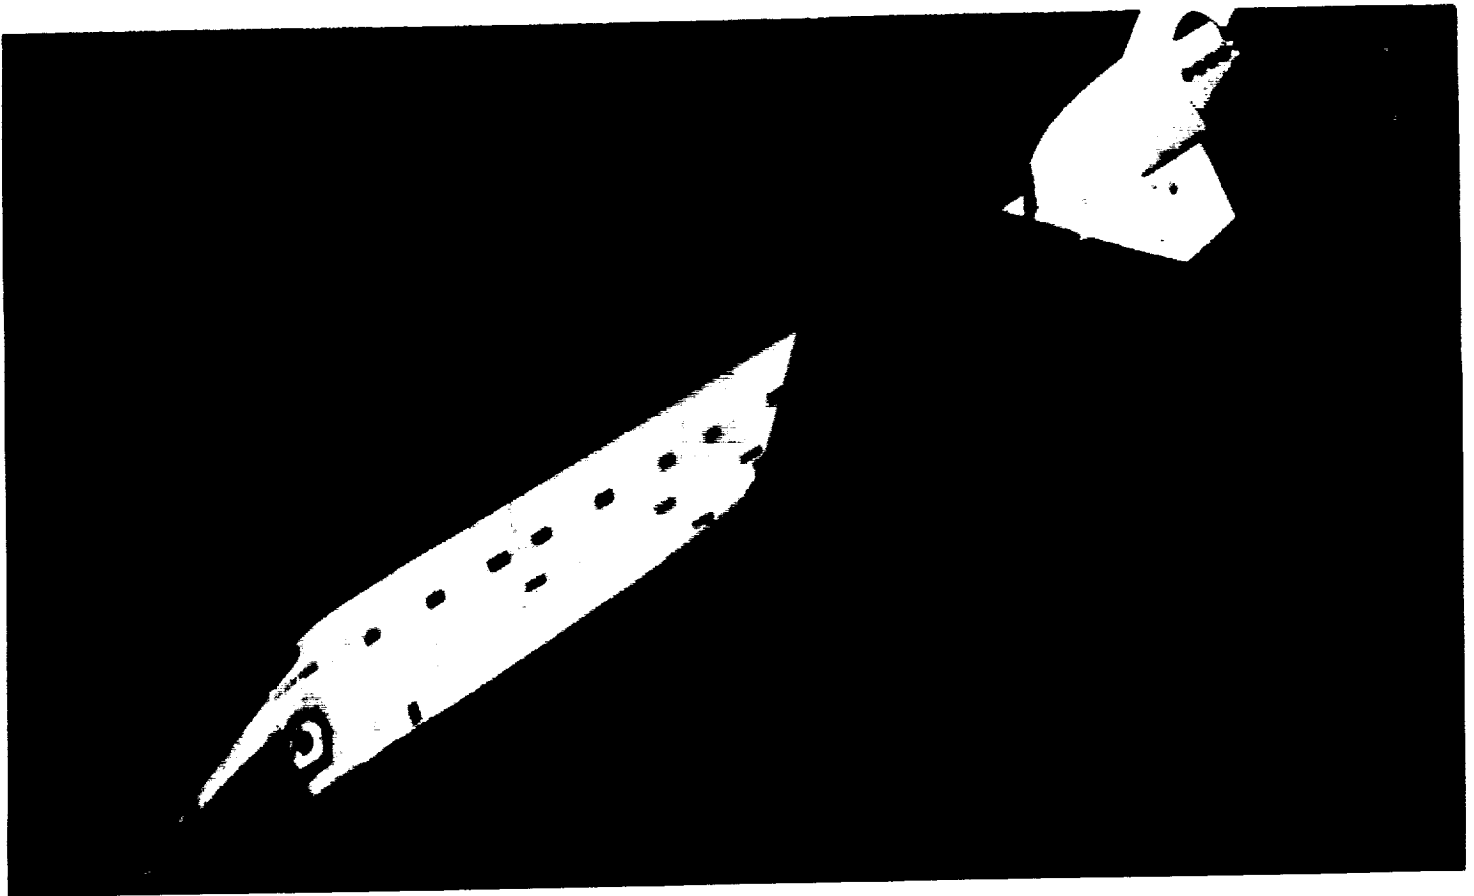
Two pieces of SSME closeout blanket, above the body flap near  
SSME #2 and outboard of SSME #3, fell aft during final approach
